## AIRCRAFT ACCIDENT REPORT

OPNAV REPORT 3750-1

PART V. THE ACCIDENT

SNJ 20-253, BuNo 112278 departed N.S. CORRY FIELD at approximately 1010 CST, on Tuesday, 23 April 1957. The flight was a precision two (2) solo training syllabus flight. The pilot was NavCad George Windsor CHIHULY. Following take-off and climbout, the student pilot intended to perform regular syllabus maneuvers which included wing-overs and Chandelles for high work, and several touch and go landings at OLF, Choctaw. It is assumed that regular syllabus maneuvers were practiced until the aircraft entered a spin and spun to the earth, crashed and burned.

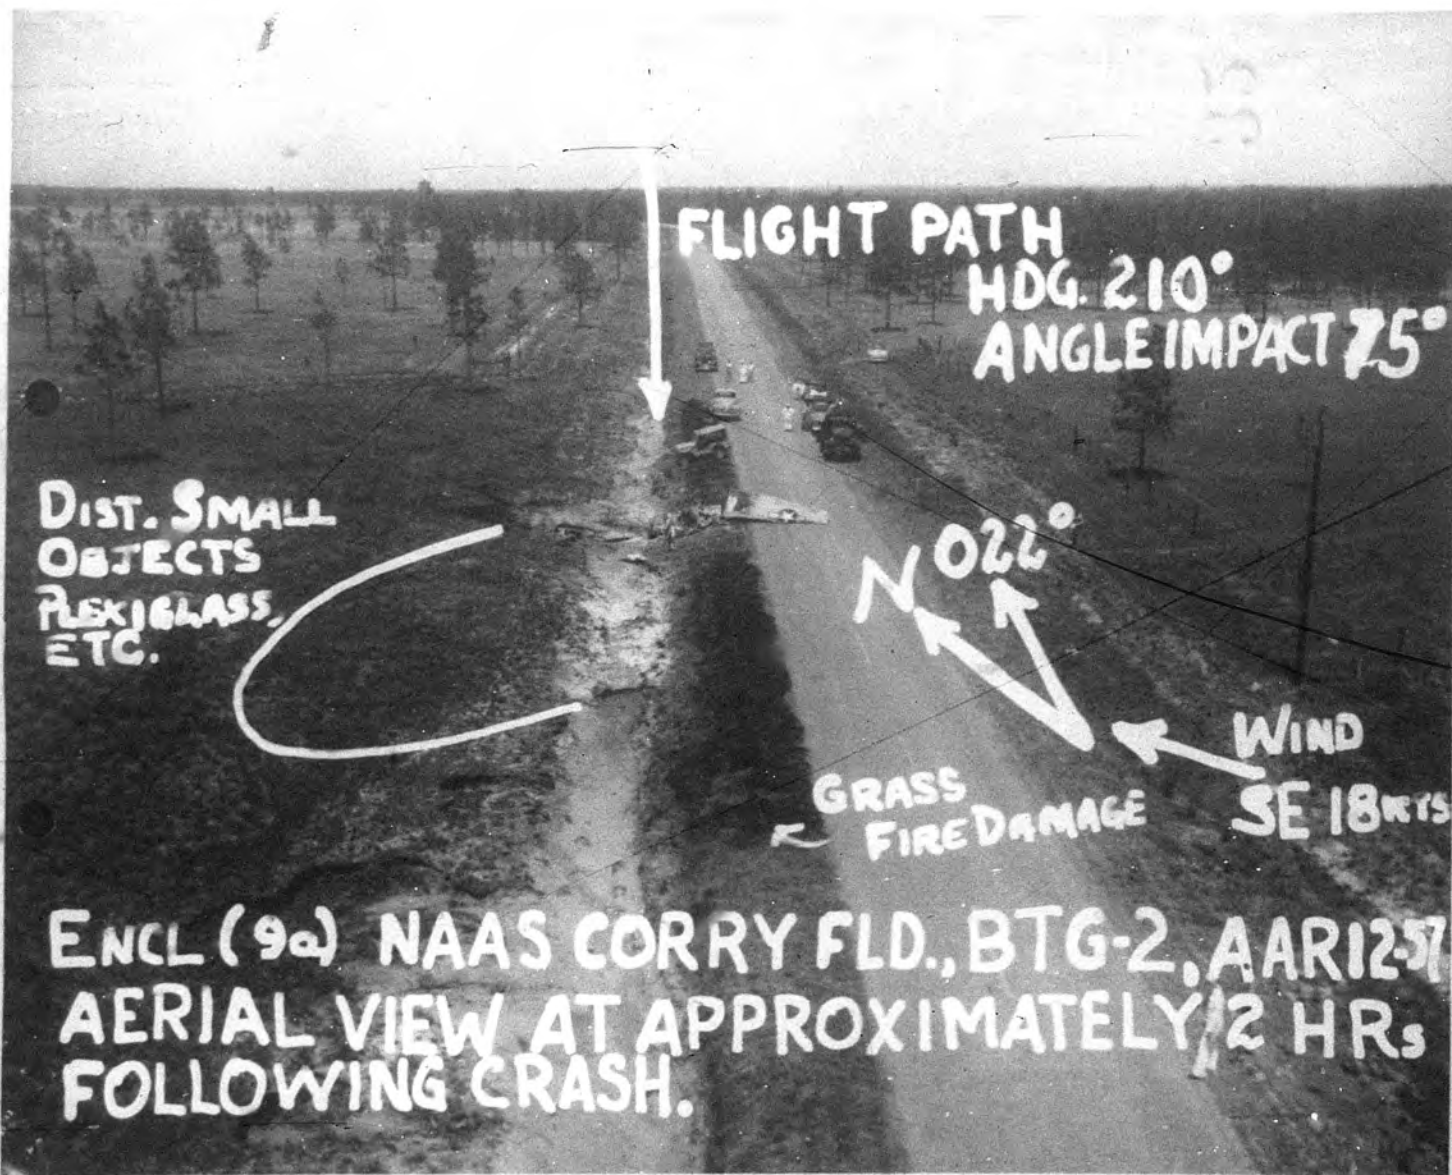
-----  
MAIN WRECKAGE  
-----

A	31	130°	Beginning port wing root
B	47'11"	135°	Port wing tip
C	25'6"	140°	Cockpit area
D	20'3"	160°	Engine area
E	21'2"	142°	Starboard wing root
F	8' 5"	170°	Stb. wing tip
G	15'7"	130°	Tail wheel and strut
H	17'10"	160°	Vert. stabilizer, rudder brace
I	15'2"	181°	Starboard side fuselage panel
